Two Approaches to Rehabilitation of Metal Roofing at Wheeler Army Airfield Hawaii

Dave Bailey

U.S. Army Corps of Engineers,
Engineer Research and Development
Center

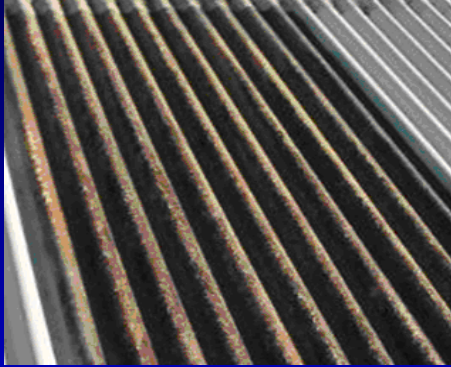
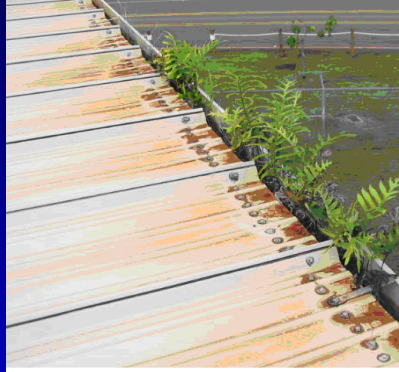
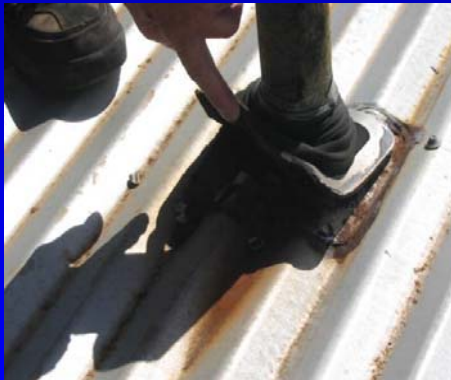
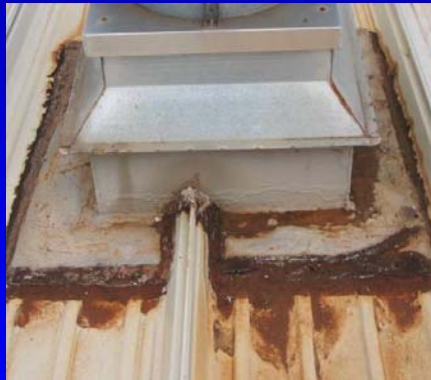
- Standing seam metal roofs (SSMR) comprise 80% of DoD new roofing
 - 1980's roofs reaching end of service life
- Early coatings with performance problems
 - Not adequate
 - Not “cool”
- Corrosion around panel-penetrating fasteners
 - Corrosion
- Improper flashing of roof penetrations

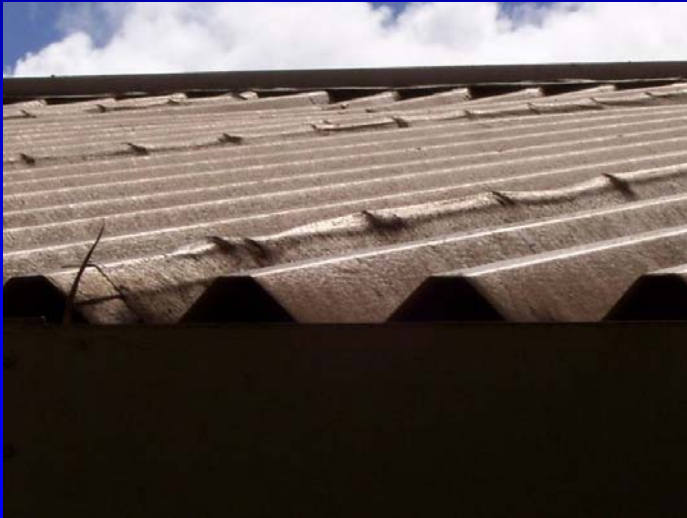
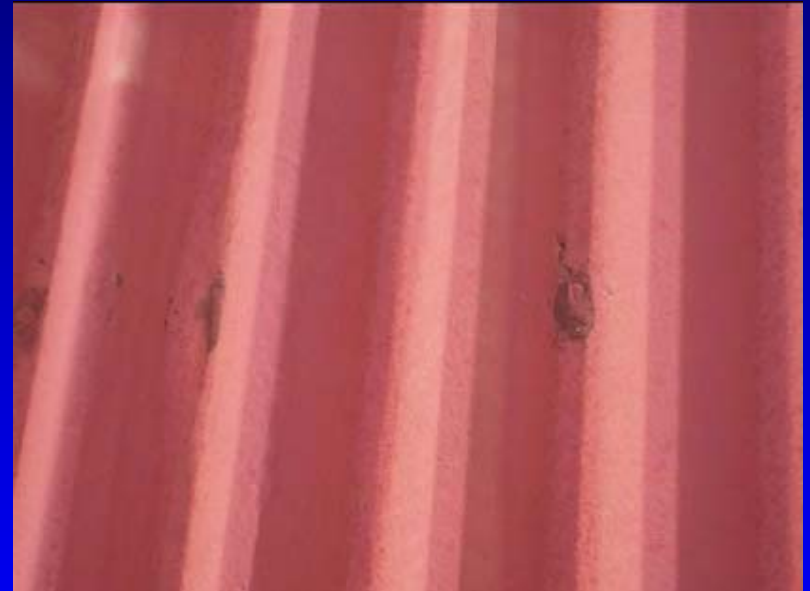
Existing Conditions

- Overlay with coating
- Some rusting
- Persistent leaking

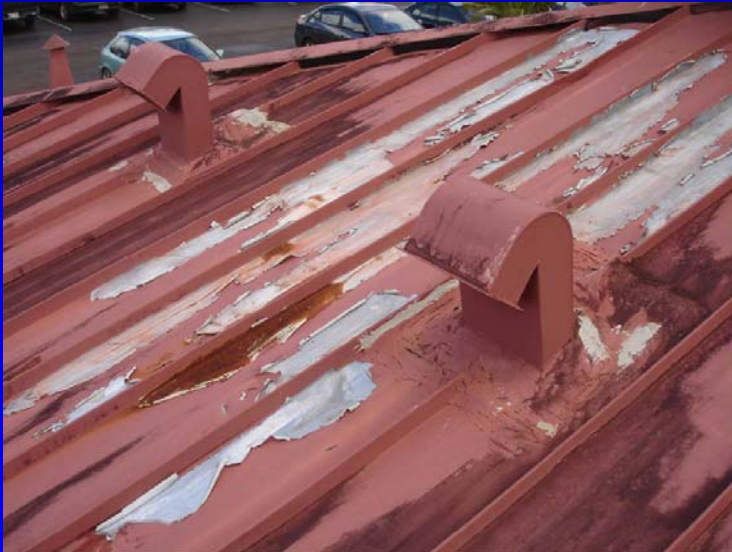
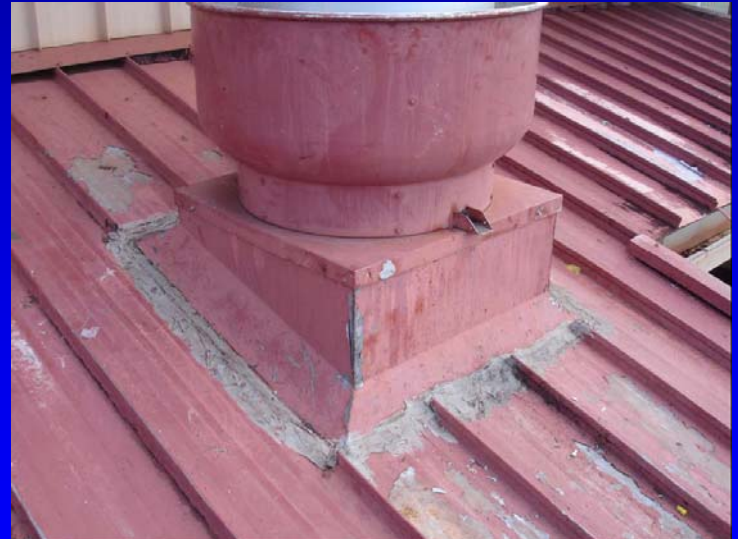
Existing Conditions

- Severe paint delamination
- Areas of rusting on panel surfaces
- Poor detailing of roof penetrations

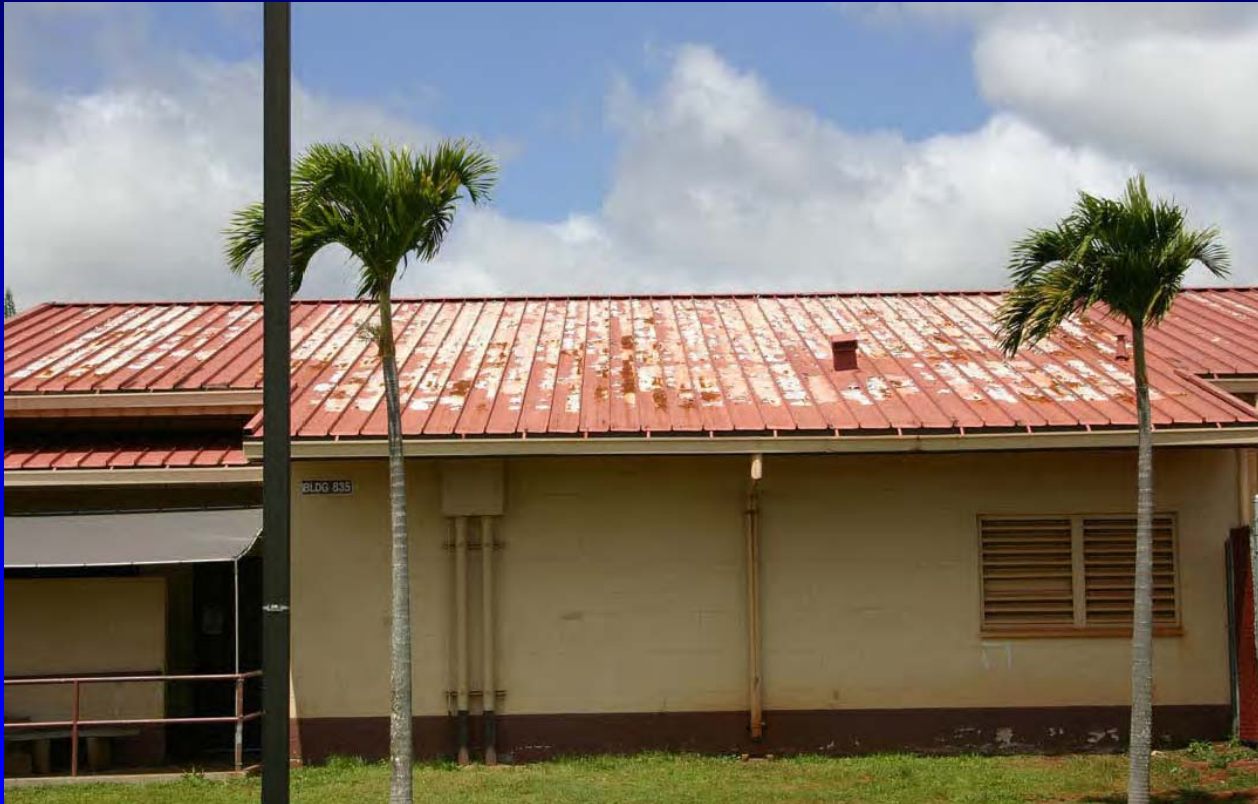
Existing Conditions
